WL-TR-96-4112

**CERAMIC BEARING DEVELOPMENT
SILICON NITRIDE BEARING BALLS OF
IMPROVED RELIABILITY: THERMAL
OXIDATION**

CHARLES B. BURK

NOVEMBER 1996

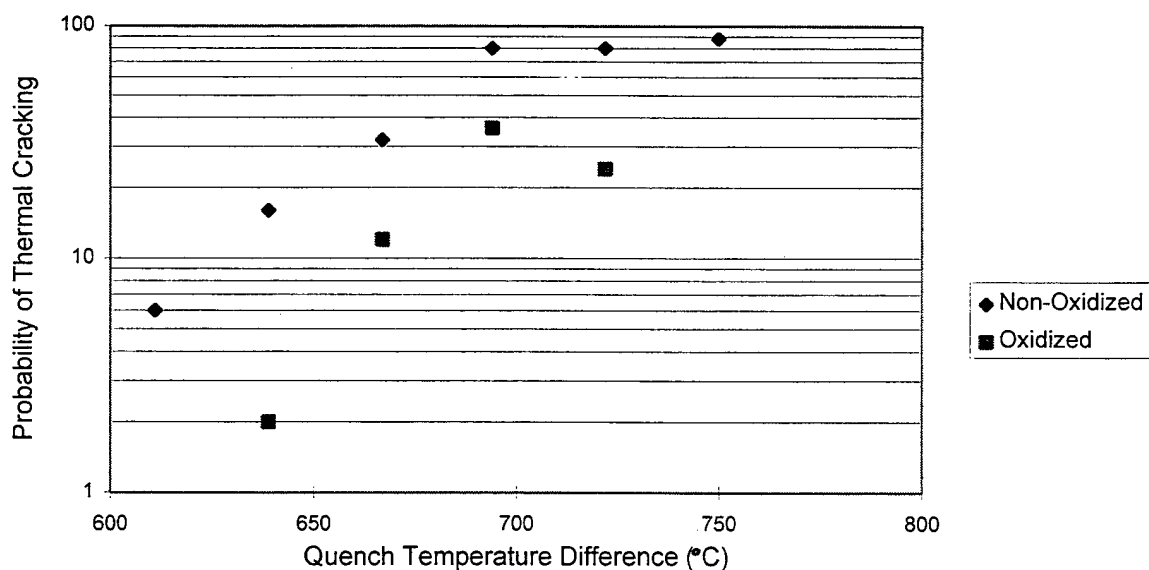
Figure 1 Weibull comparison: oxidized vs non-oxidized balls.

A Weibull plot comparing the baseline result to the "optimum" oxidation treatment result is shown in Figure 1. At higher quench temperature differences, there is a plateau in the data. The oxidized balls are more resistant to thermal cracking than the non-oxidized balls. Eighty oxidized balls were prepared for RCF testing and other analyses using the "optimum" oxidation treatment.

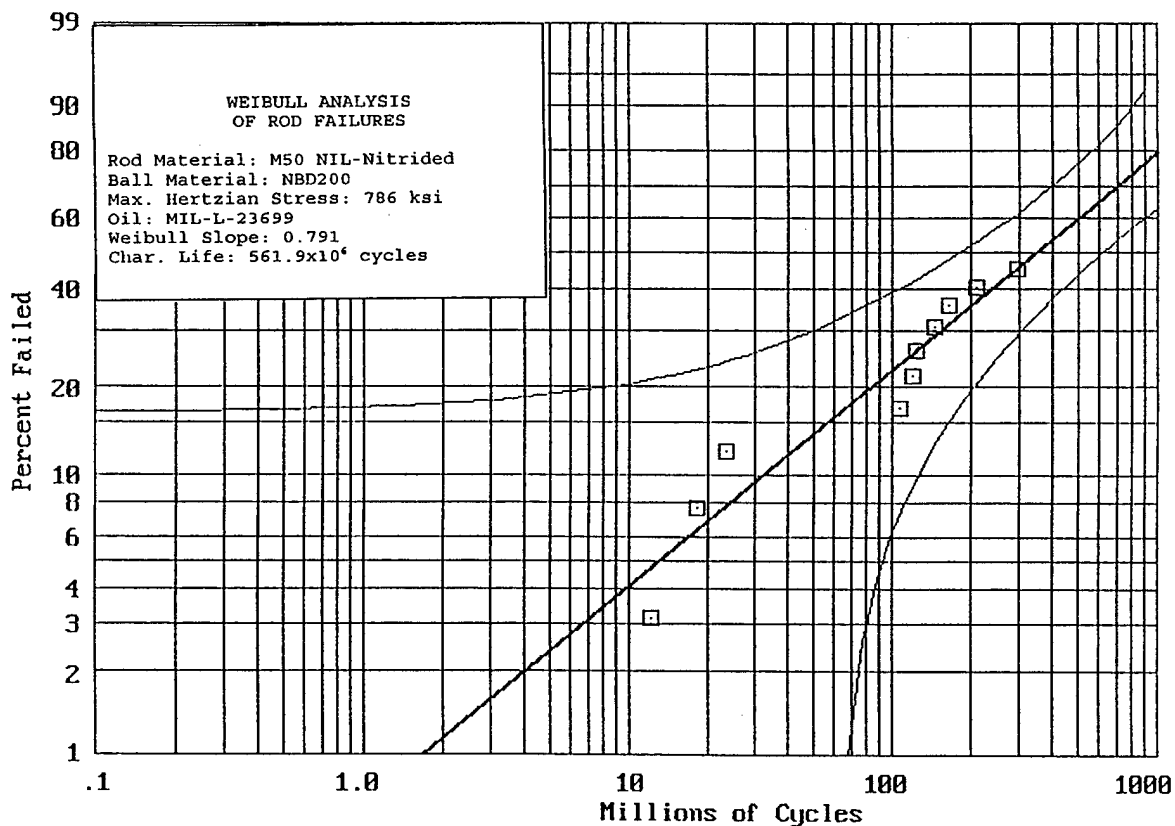
Figure 3 Weibull analysis of rod failures, 561.9 million cycles.

While the test data do not provide a basis for comparing the fatigue lives of the oxidized and non-oxidized balls, it is possible to compare the fatigue lives of the rods with the different balls. Figures 3 and 4 show the Weibull plots for the rod failures with non-oxidized and oxidized balls respectively.

There are distinct differences between the two sets of data. With the non-oxidized balls, the rod B_{10} life was approximately 30×10^6 cycles, but with the oxidized balls it was only 10×10^6 cycles. The Weibull slopes of 0.791 (non-oxidized) and 1.15 (oxidized) both indicate a random type of failure. With the non-oxidized balls, seven of the ten rod failures were in excess of 100×10^6 cycles; whereas, with the oxidized balls, none of the fifteen rod failures exceeded that value. Overall, the life of the nitrided M50 NIL rods was lower with the oxidized balls.

Referring back to Figure 3, there appears to be two groups of data with the non-oxidized balls. Three failures occurred in the $10 - 30 \times 10^6$ cycle range while the other seven failures were in excess of 100×10^6 cycles.

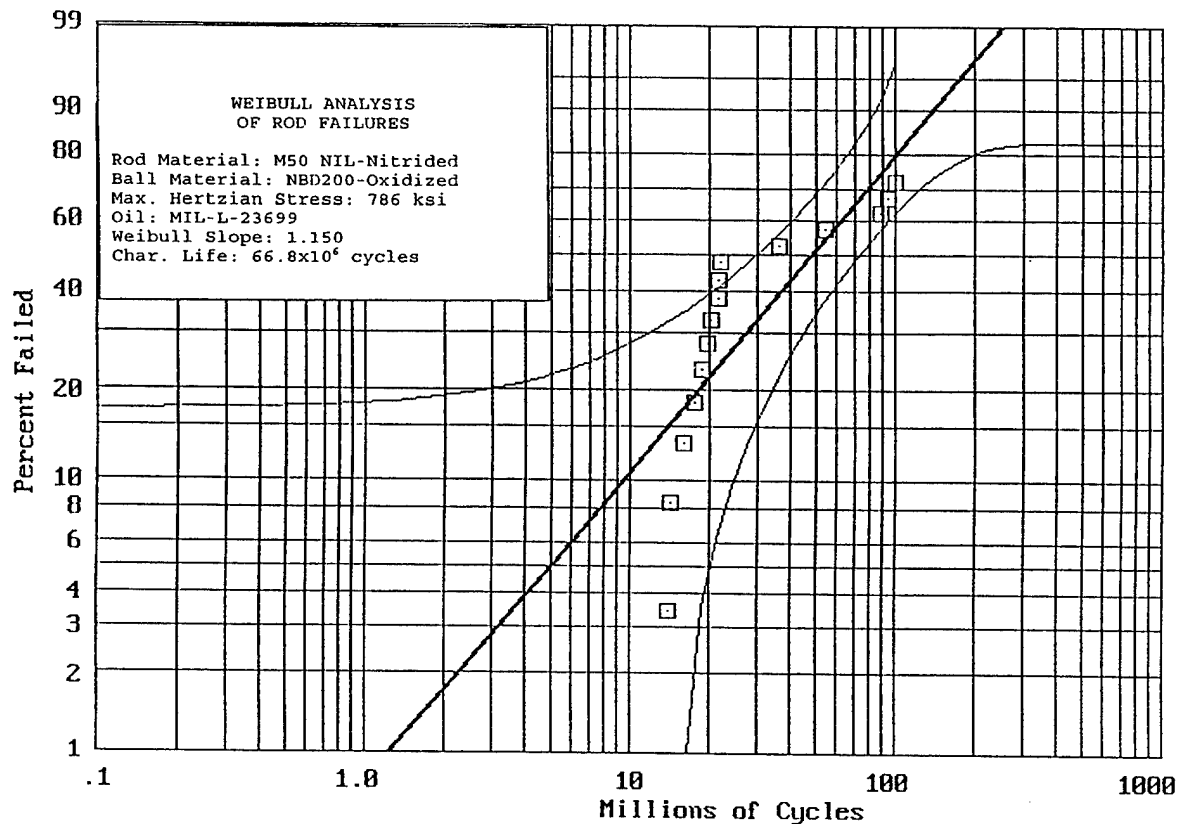
Figure 4 Weibull analysis of rod failures, 66.8 million cycles.

The data with the oxidized balls, Figure 4, give poor correlation to the Weibull line and it appears that there might be two different failure modes involved. There is a group of ten failures over a narrow range of $13.98 - 21.93 \times 10^6$ cycles, while the other five failures appear to be out of line with the first group. Figure 5 shows the results of a Weibull analysis of the first ten failures.

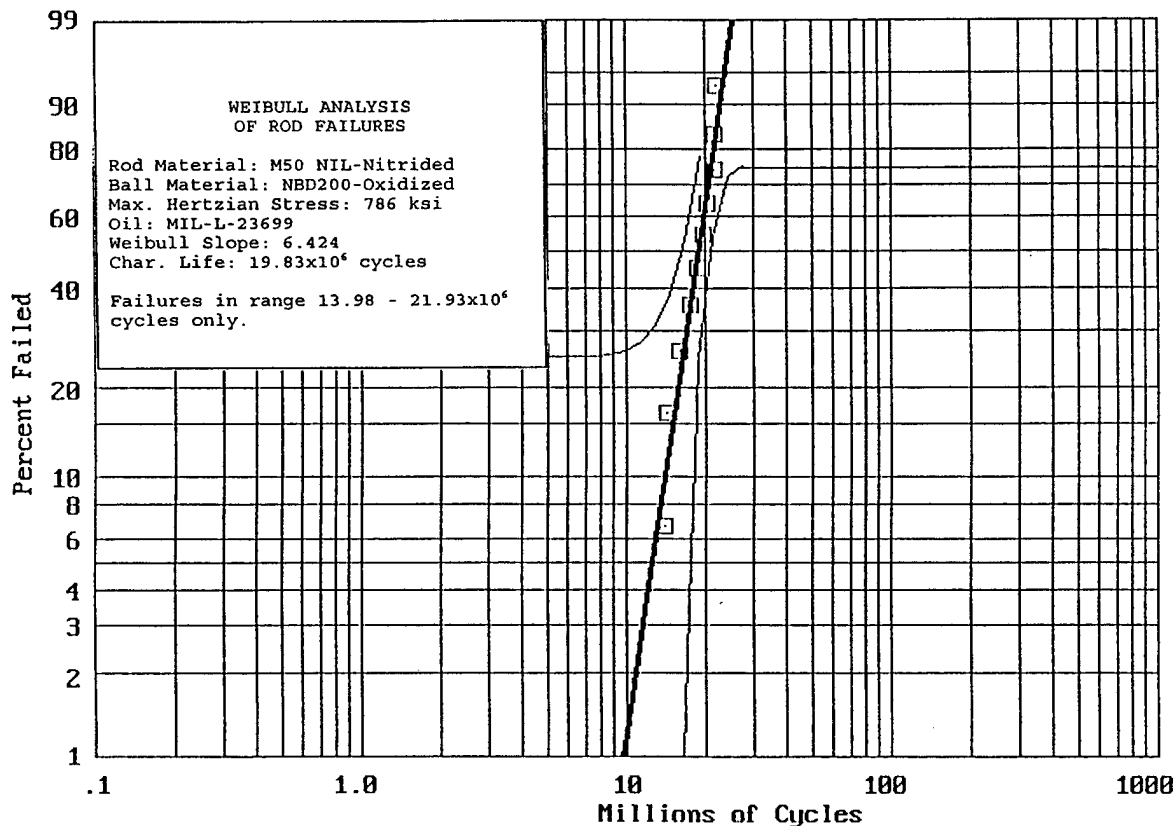
Figure 5 Weibull analysis of rod failures, 13.98 - 21.93 million cycle range.

The data show very good correlation to the Weibull line, which has a high slope of 6.424. The results of a Weibull analysis of the other five failures is shown in Figure 6. Again, the data correlate well with the line but the slope is lower at 2.303. Based on the analyses of the two groups of data, there is reason to believe that there are two different processes leading to failure of the rods. Inspection of the spalls on the rods does not show any significant differences between the two groups of failures. The test heads were all calibrated prior to each test and adjusted to give the same nominal Hertzian stress so this should not have influenced the failures. This would appear to leave two possibilities; inconsistency of the rod material possibly from the nitriding process or inconsistency of the ball material possibly from the oxidizing process. If the phenomenon was the result of inconsistent rod material, one would expect to see a similar pattern in the rod failures generated with the non-oxidized balls, since the tests were carried out on the same rods.

Comparing this to the "equivalent" data with the oxidized balls (Figure 5), the line for the non-oxidized balls falls within the 90% confidence band of the line for the oxidized balls. This suggests that, at the 90% confidence level, there is no significant difference in the early rod failures generated with oxidized and non-oxidized balls.

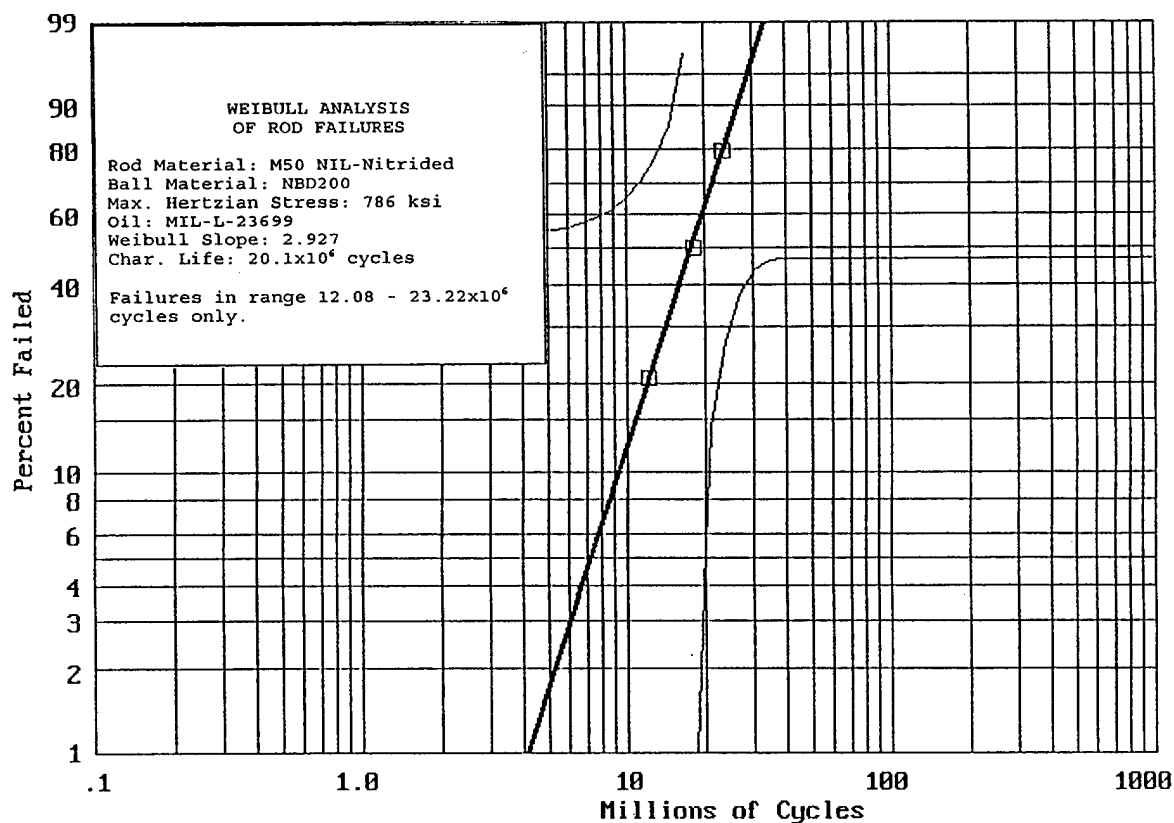
Figure 7 Weibull analysis of rod failures, 12.08 - 23.22 million cycle range.

Figure 7 shows the results of a Weibull analysis of the three early failures.

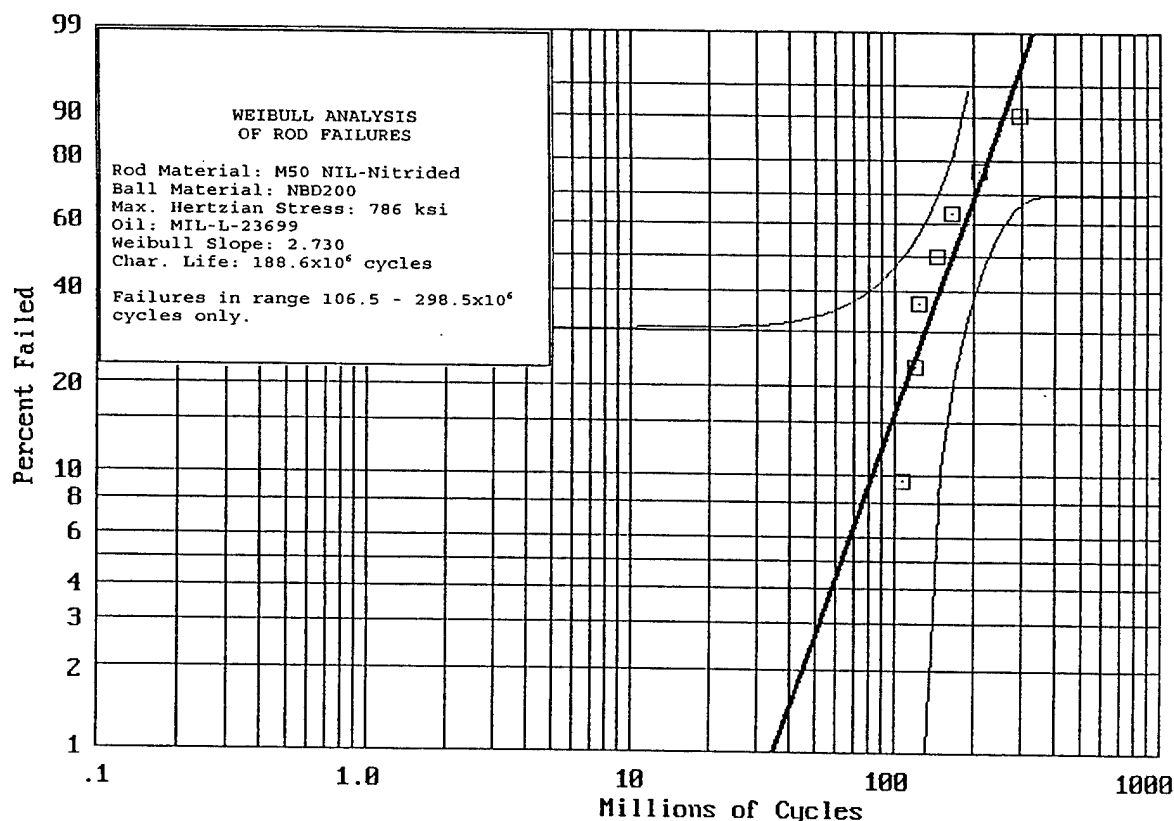
Figure 8 Weibull analysis of rod failures, 106.5 - 298.5 million cycle range.

The result of Weibull analysis of the seven higher failures with non-oxidized balls is shown in Figure 8. Comparing this with the equivalent data for the oxidized balls shown in Figure 6, the two lines have a similar slope, but the rod life with the non-oxidized balls is at least twice that with the oxidized balls.
